Apollo 1 Malfunction Procedures (A204) for Apollo Operations Handbook

APOLLO 1 MALFUNCTION PROCEDURES

GUIDANCE AND NAVIGATION MALFUNCTION PROCEDURES

SCS MALFUNCTION PROCEDURES

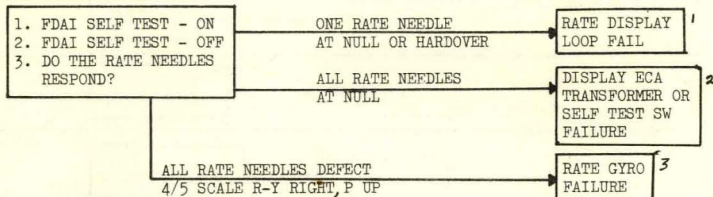
1. LAUNCH: NO ACTION
BALL, ATTITUDE ERROR INDICATORS, AND PHYSICAL SENSES ARE AVAILABLE AS BACKUP RATE CUES. USE DISPLAY SELF CHECK AFTER INJECTION.

MIDCOURSE, ΔV 'S & ENTRY: BALL OR EXTERNAL REFERENCES, ATTITUDE ERROR INDICATORS, AND/OR PHYSICAL SENSES ARE AVAILABLE AS BACKUP RATE CUES. DISREGARD RATE DISPLAY IN AFFECTED AXIS.
2. ALL PHASES: DISPLAY SELF TEST FUNCTION IS LOST. USE CROSS CHECK OF BALL OR EXTERNAL REFERENCES, ATTITUDE ERROR INDICATORS, AND/OR PHYSICAL SENSES FOR CORRECT RATE CONTROL RESPONSE FOR REMAINDER OF MISSION. IF TRANSFORMER FAILED GPI DISPLAY WILL NOT FUNCTION PROPERLY.
3. TBD
