1-27-1967

Apollo 1 Malfunction Procedures Manual

National Aeronautics and Space Administration (NASA)

APOLLO 1 MALFUNCTION PROCEDURES

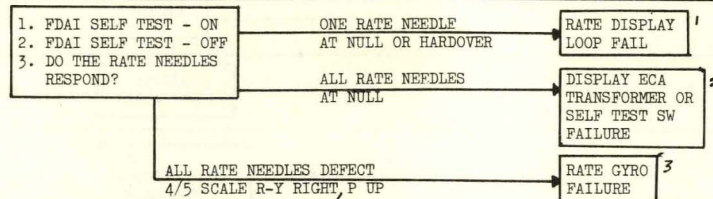
1. LAUNCH: NO ACTION

BALL, ATTITUDE ERROR INDICATORS, AND PHYSICAL SENSES ARE AVAILABLE AS BACKUP RATE CUES. USE DISPLAY SELF CHECK AFTER INJECTION.

2. ALL PHASES: DISPLAY SELF TEST FUNCTION IS LOST. USE CROSS CHECK OF BALL OR EXTERNAL REFERENCES, ATTITUDE ERROR INDICATORS, AND/OR PHYSICAL SENSES FOR CORRECT RATE CONTROL RESPONSE FOR REMAINDER OF MISSION. IF TRANSFORMER FAILED GPI DISPLAY WILL NOT FUNCTION PROPERLY.

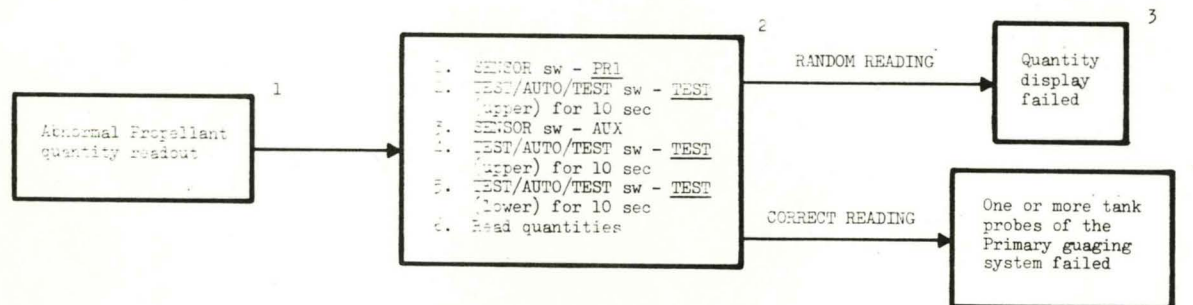
SYSTEM	SPS-5
DATE	FEB. 16, 1967
S/C	012

1. Complete any thrusting activity prior to check of quantity readout.
2. In TEST mode the display will not move for the first 4.5 sec. Next it will race for 1 sec, and then will roll steadily at 2 to 4 digits per sec. If display reacts as above after primary system failure, then failure is in a tank probe. If tank probe is not failed, then random or bogey readings will be displayed.
3. MSFN must not supply any propellant quantity data.
4. Continue in AUX mode. Telemetry will provide total quantities from auxiliary system, and sump tank quantities from PRI system.
