APOLLO

GUIDANCE, NAVIGATION AND CONTROL

APOLLO II GYRO PROCUREMENT
FINAL REPORT TASK ORDER 33

R. J. Cooper

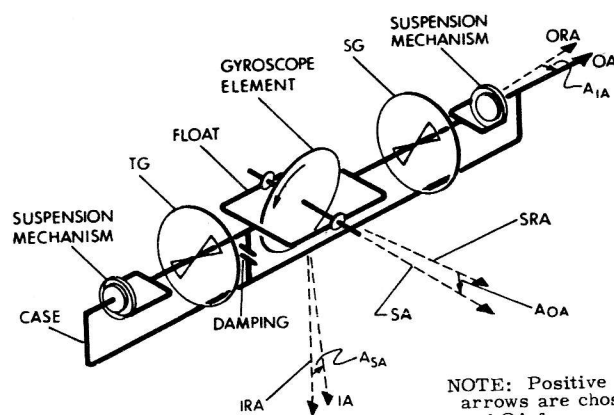
Fig. 2-1. Line schematic of SDF floated integrating gyro unit.

The Apollo II gyro is a single degree of freedom, floated, integrating instrument and has the primary function of stabilizing the platform in the Inertial Measurement Unit of the Apollo Guidance and Navigation System. It consists of a spherical beryllium float containing an electrically driven, ball bearing mounted wheel, signal generator and torque generator microsyns and temperature control sensors all contained within a fluid filled, thermally and magnetically shielded housing. A line schematic is shown in Figure 2-1.

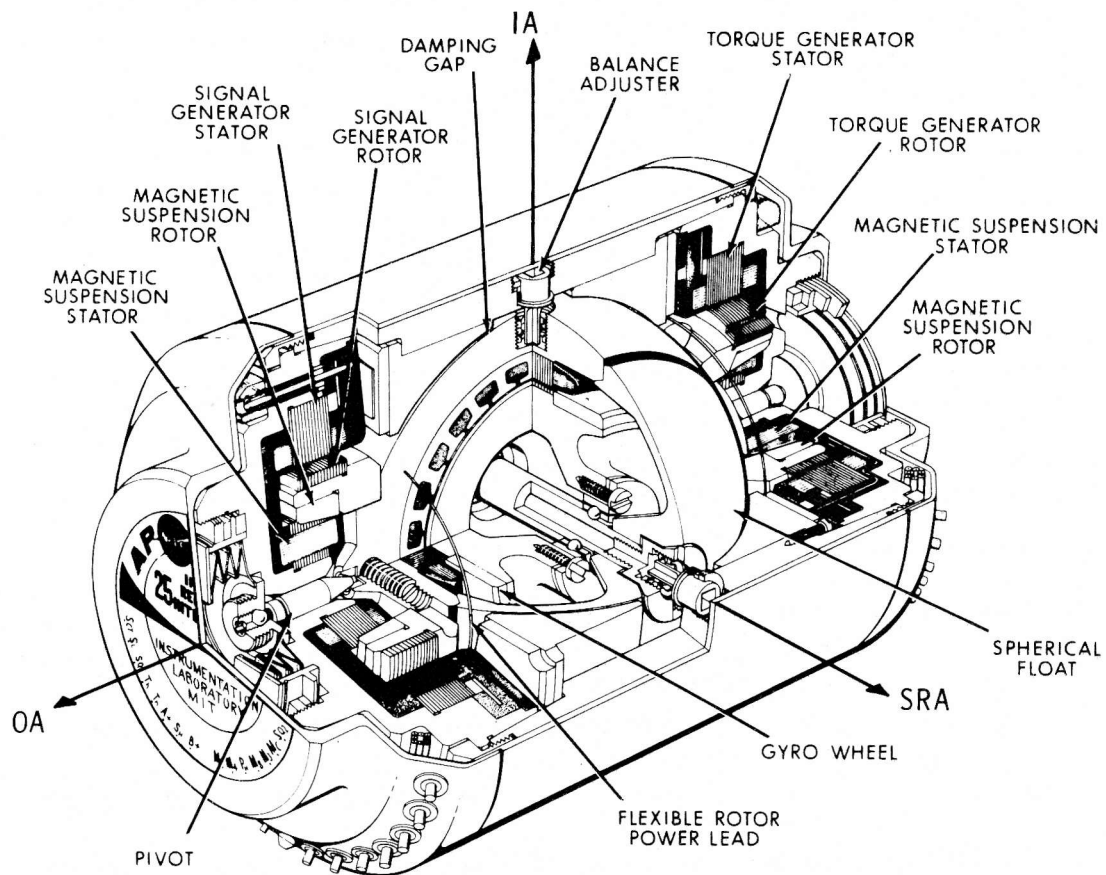
Fig. 2-2 Apollo IRIG

A cutaway view of the Apollo II gyro is shown in Figure 2-2. The wheel is a symmetrical structure rotating about a fixed shaft on an integral R2 size, pre-loaded ball bearing inner race. It is driven by a two-phase hysteresis motor at 24,000 ~~rpm~~ ^{RPM}. The wheel is shaft mounted within a hermetically sealed float where a dry helium atmosphere of approximately 7 psia inhibits corrosion, promotes thermal transfer and minimizes windage torques. The float carries the rotors associated with the TG and SG ducosyns and contains provisions to permit the float to be balanced about the input and spin axes. The float is suspended within the gyro housing by matching the float density to the density of a bromotrifluoroethylene floatation fluid and by the magnetic suspensions incorporated in the ducosyns. This fluid has the required viscosity necessary to provide the proper output axis damping. To eliminate extraneous torques resulting from possible fluid separation or stratification, the molecular weight distribution of the fluid is rigidly controlled.
