Pressure-based flowmeter calculations

Questions

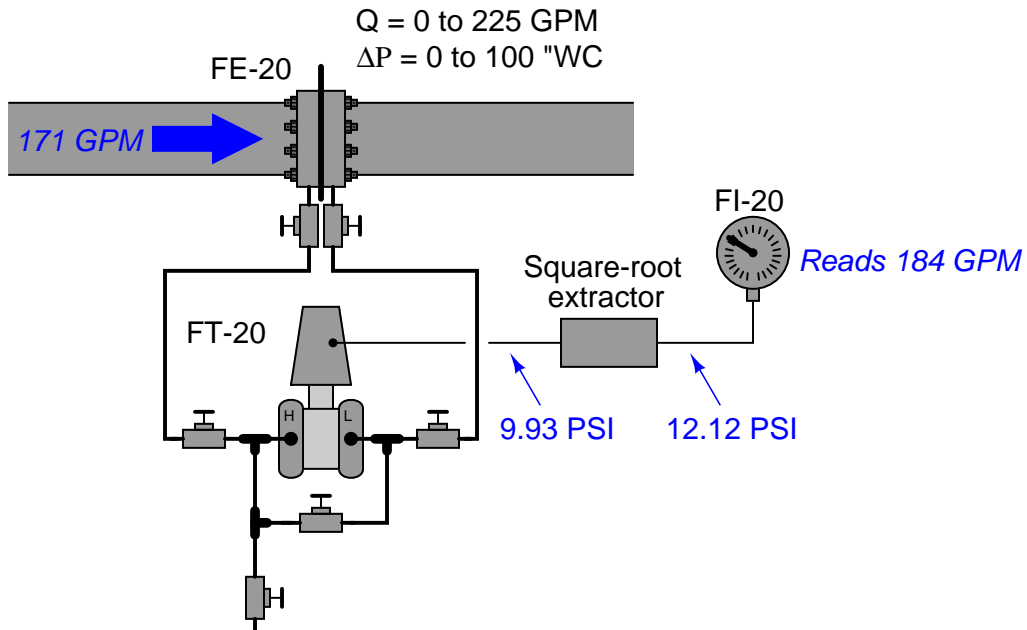
Question 3

A pneumatic DP transmitter measures the flow of gasoline through a an orifice plate, using a separate square root extractor relay to characterize the signal so that it may be displayed linearly on the receiver gauge (FI-20):

Based on other flow-measuring devices in this process, operations personnel have determined the actual flow rate through this pipe is 171 gallons per minute. FI-20, however, registers a flow of 184 gallons per minute. Based on the data you see in this illustration, determine the location of the calibration error.

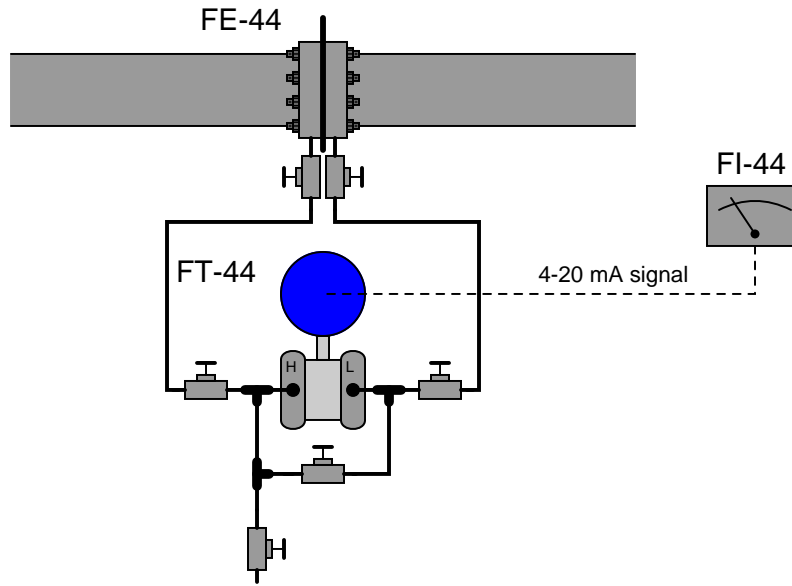
Question 4

A “smart” DP transmitter with built-in square root characterization is used to measure flow through a pipe. The orifice plate range is 0 to 125 inches WC at 0 to 277 gallons per minute:

A technician removes the transmitter from service and tests it by applying several air pressures to the “H” port while leaving the “L” port vented. Here are the As-Found results:

Applied Pressure (”WC)	Current signal (mA)
0	4.020
31.25	12.060
62.5	15.390
93.75	17.946
125	20.100
