# SCS SIGNAL AND POWER CODE

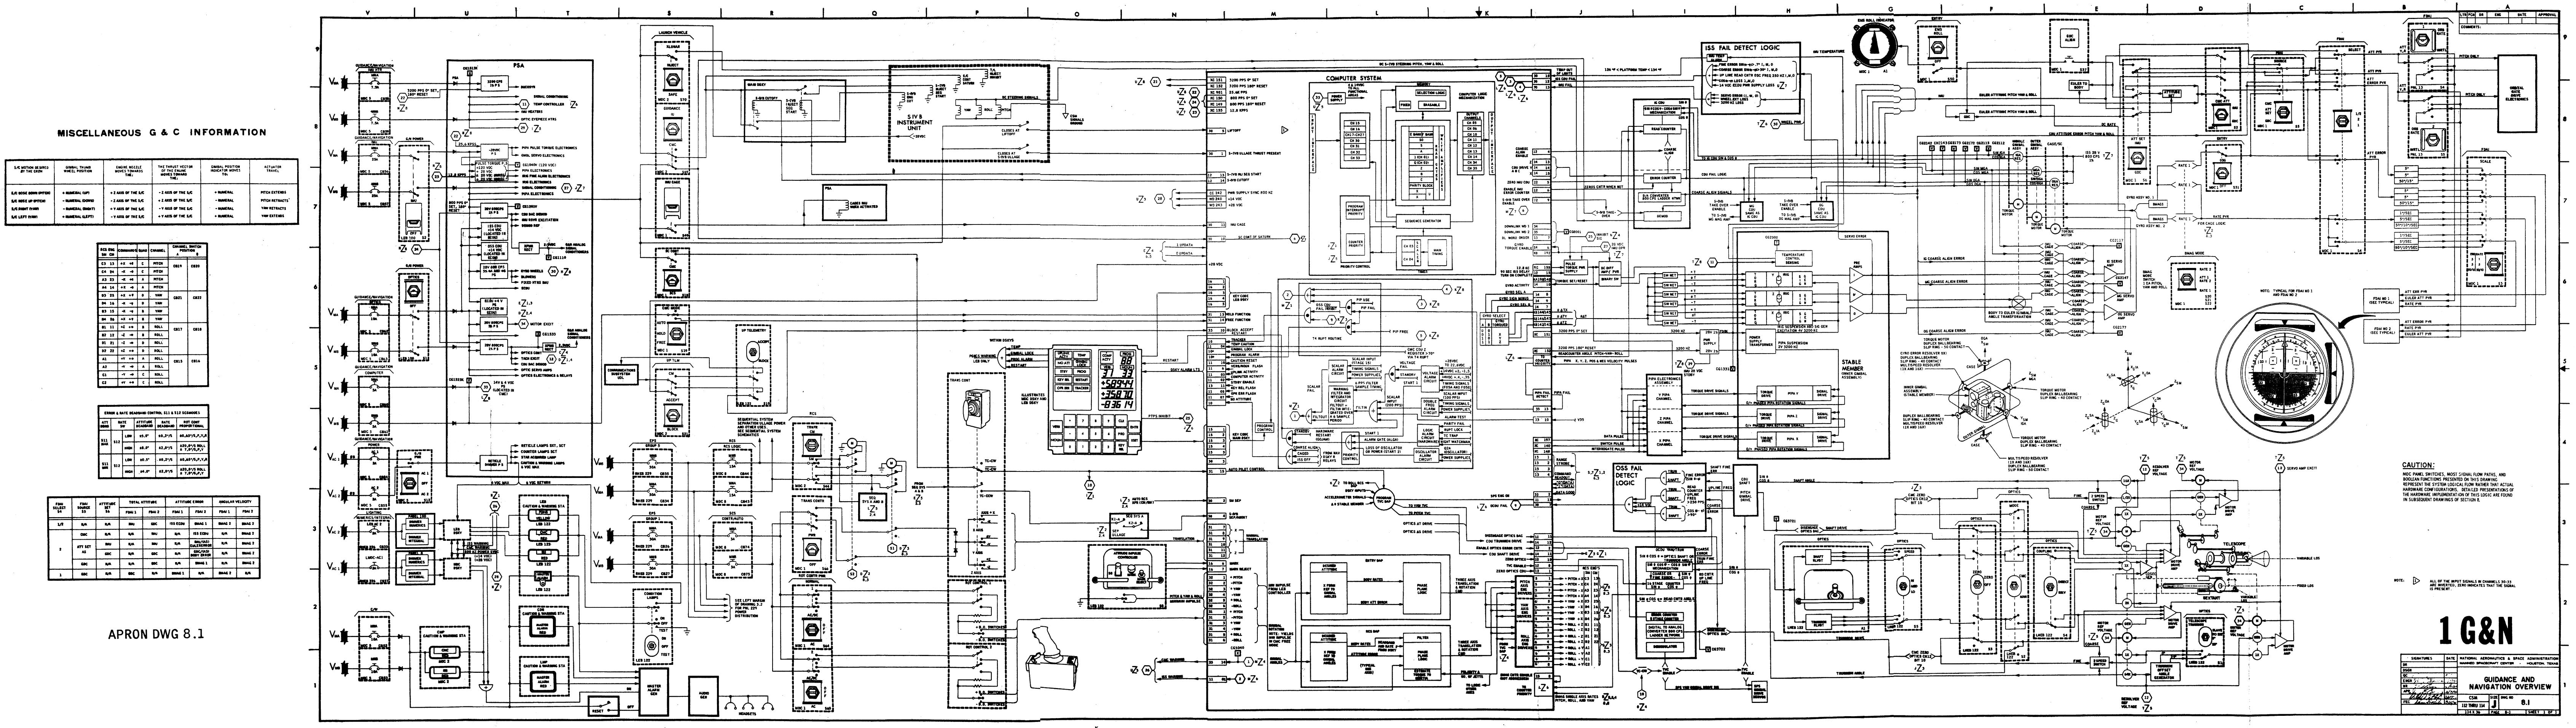
CODE	TYPE OR POWER	CODE	TYPE OF POWER
01	27.5Vdc	40	GA2 ac RATE
02	±20 Vdc	41	dc RATE
03	10 Vac	42	ENGINE ON WITH 1 S
04	2.2 KHz	43	ENGINE ON/OFF 1 SE
05	25 Vac	44	MODE SELECTED SC
06	±15 Vdc	45	PITCH GYRO UNCAGE
07	±14.5 Vdc	46	YAW GYRO UNCAGE
80	400 Hz SPIN MOTOR POWER	47	ROLL GYRO UNCAGE
09	26 Vac 400 Hz REFERENCE	48	SIG COND POWER ±1
10	14 Vdc	49	115 V 400 Hz PHASE
11	13 Vdc	50	MODE SELECTED CM
12	-15 Vdc	51	PITCH AUTO CNTL D
13	+20 Vdc	52	YAW AUTO CNTL DIS
14	±32 Vdc	53	ROLL AUTO CNTL DI
15	±32 Vdc	54	PITCH ACCEL CMD E
M	400 Hz 26 V BUS 1 SWITCH 3 OR 800 Hz	55	YAW ACCEL CMD EN
	0 PHASE IMU	56	ROLL ACCEL CMD E
N	400 Hz 26 Vac BUS 2 SWITCH 3 OR 800 Hz	57	DIRECT ULLAGE PIT
<b>D</b>	0 PHASE IMU 400 Hz 26 Vac BIS 2 SWITCH 3 OR 400 Hz	58	DIRECT ULLAGE YAV
Р	26 Vac BUS 1 SWITCH 6 OR 800 Hz	59	.05g OFF
	O PHASE IMU	60	GDC EULER
16	+X TRANSLATION	61	.05g <b>ON</b>
17	-X TRANSLATION	R	400/800 CPS OUT F
18	+Y TRANSLATION	_	SIG DEMOD

19	-Y TRANSLATION	S	400/800 CPS OUT F SIG DEMOD
20	+Z TRANSLATION	T	FDAI 1 AND 2 PYR F
21	-Z TRANSLATION	62	115 V 400 Hz
22	PITCH RATE COMMAND	63	26 Vac <90°, 400 H
23	YAW RATE COMMAND	64	A/C ROLL ENGINE P
24	ROLL RATE COMMAND	65	B/D ROLL REACTION
25	PITCH MIN IMP		CB18, MDC 8
26	YAW MIN IMP	66	PITCH REACTION EN
27	ROLL MIN IMP	W = 40	CB20, MDC 8
28	PITCH DIRECT (C3-A4)	67	YAW REACTION ENG MDC 8
29	YAW DIRECT (D3-B4)	68	REACTION ENGINE
30	ROLL DIRECT (B1-D1, B2, D2)	30	POWER CB74 A
31	SCS LOGIC BUS 1	69	RCS LOGIC POWER
32	SCS LOGIC BUS 2		PNL 229
33	SCS LOGIC BUS 3	70	SEQ A SPS THRUST SEP ULLAGE
34	SCS LOGIC BUS 4	71	SEQ B SPS THRUST
35	-4 Vdc	/ 1	SEP ULLAGE
36	TRANSLATION CONTROL CLOCKWISE	72	PITCH DIRECT (A3
37	SCS CONTROL MODE	73	YAW DIRECT (B3-D
38	RCS ERROR	74	ROLL DIRECT (A1-
39	GA1 ac RATE OR ATTITUDE ERROR

Note: Codes 100 and up designate drawing interconnections from 8.2 to 8.3 only.
