LUMINARY Memo #236

To: Distribution
From: L. Berman
Date: 23 December 1971
Subject: Crew Corrections for Cross Range Error due to Uncompensated
.Orbit Precession

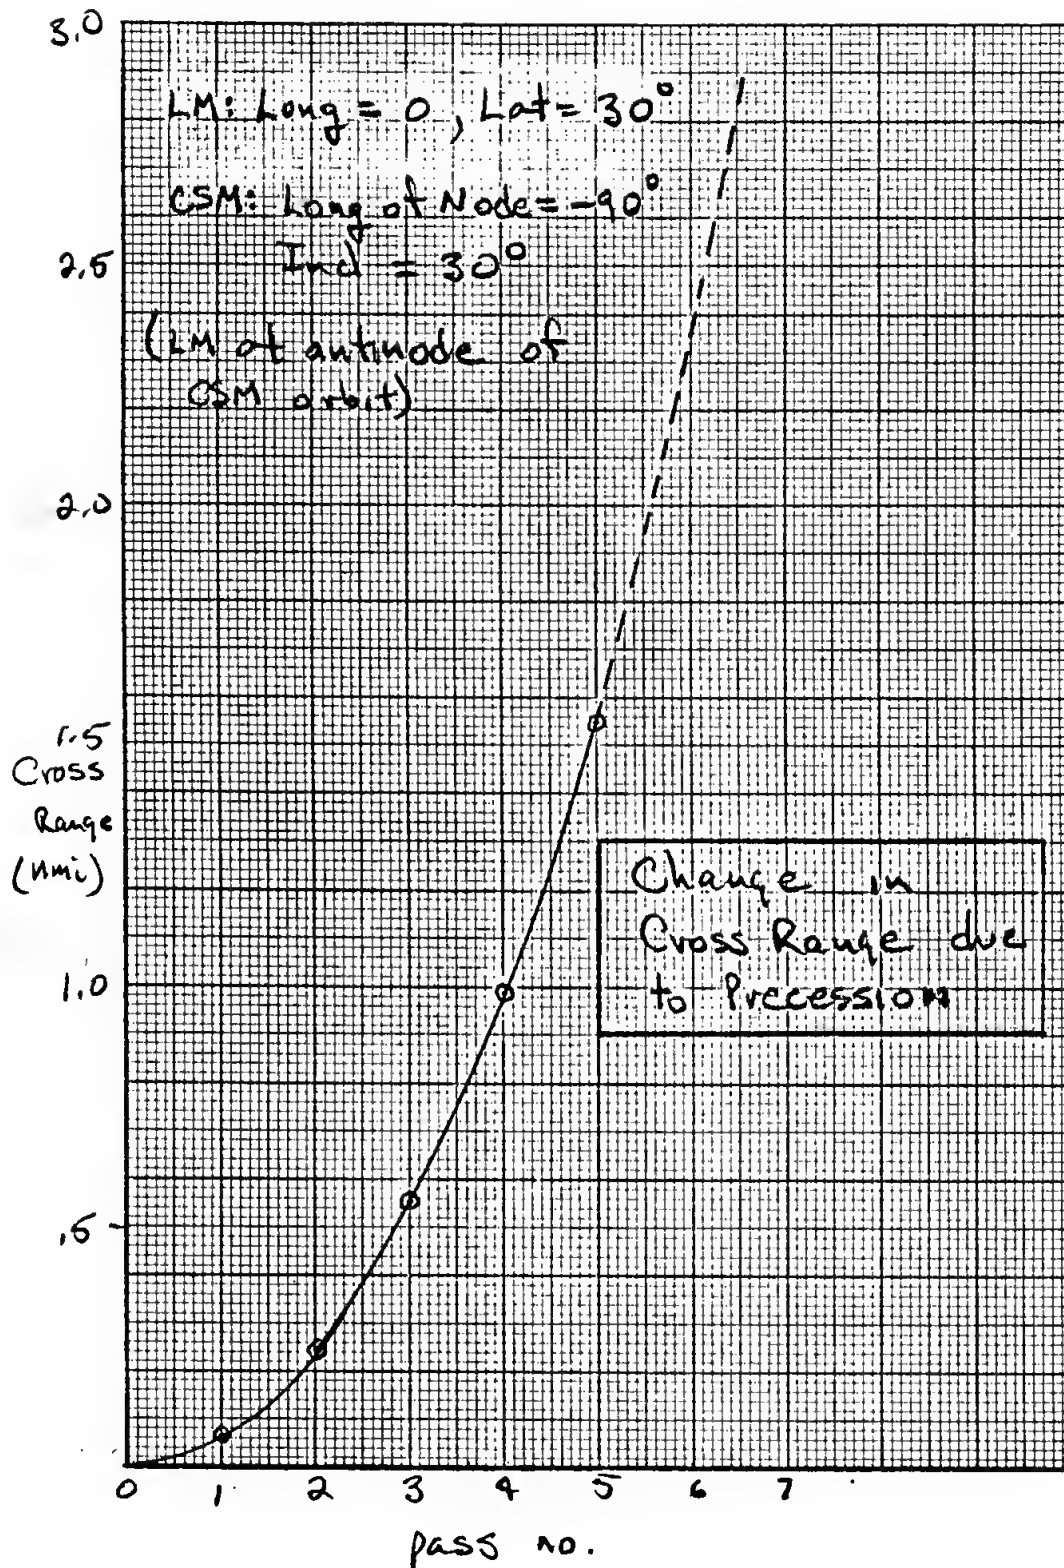
The attached figure shows the cross range for a 30° CSM orbit inclination, with the LM site at the anti-node at $t = 0$. This type of plot could be provided for actual RLS and CSM orbit, and the crew can then modify their response to Noun 76 to include this correction.

This correction can result in the insertion point being in the CSM orbit. It does not, however, account for the changed orientation of the CSM plane, and the LM may still have an incorrect heading at insertion.
