APOLLO GUIDANCE AND CONTROL
SYSTEM FLIGHT EXPERIENCE

John E. Miller, Ain Laats

JUNE 1969

**MIT INSTRUMENTATION
LABORATORY**

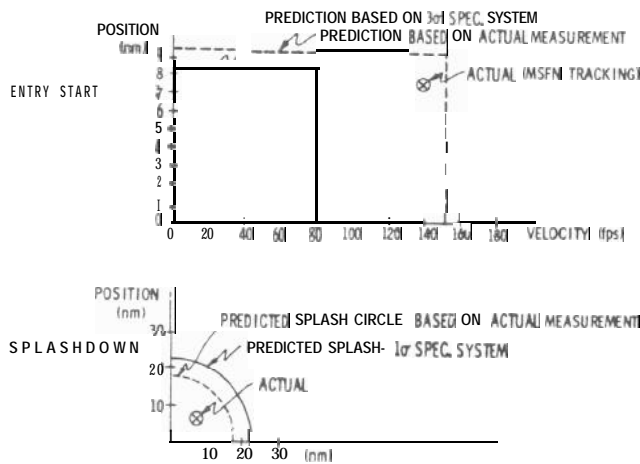
Figure 3 Comparison of Predicted and Actual Entry Errors on Apollo 4

Each mission in the Apollo program is unique. A separate error analysis is performed for each mission. The mission performance requirements were defined early in the Apollo program based upon a typical lunar landing. Because of the variety of missions and mission objectives, it is necessary to have a separate error analysis for each mission. For all missions except Apollo 5 the segmented mission phase approach to error analysis using a linearization technique is entirely adequate and was pursued. An error analysis is conducted using both the specification values, as well as the demonstrated values, for the GN&C system. A comparison of specification, actual ground measurement, and flight results for selected mission phases is presented in Table I, and in Figures 3,4,5,6, and 7.

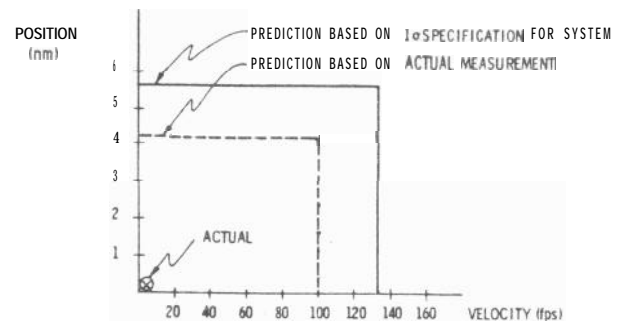
Figure 4 Comparison of Predicted and Actual SIVB Cutoff Errors on Apollo 5

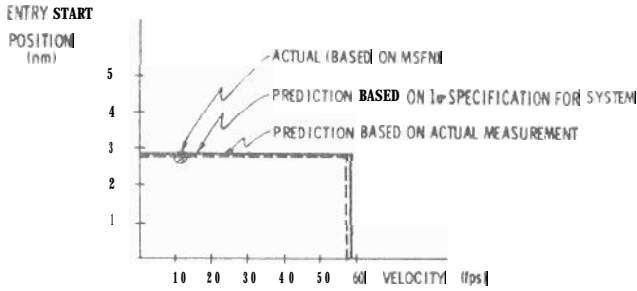
Figure 5 Comparison of Predicted and Actual Apollo 6 Entry Errors

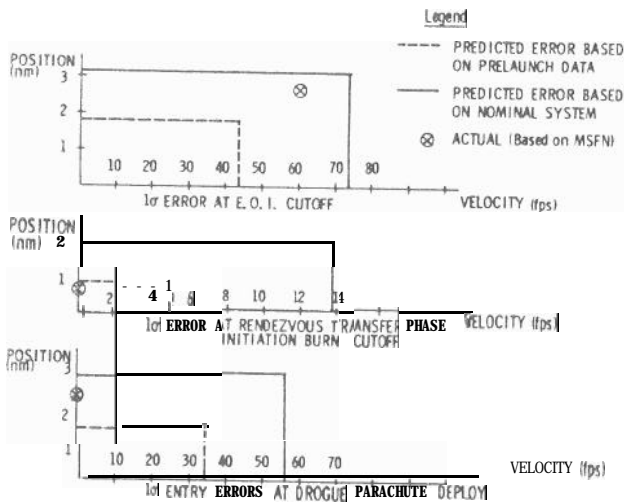
Figure 7 Comparison of Apollo 7 Predicted and Actual System Errors

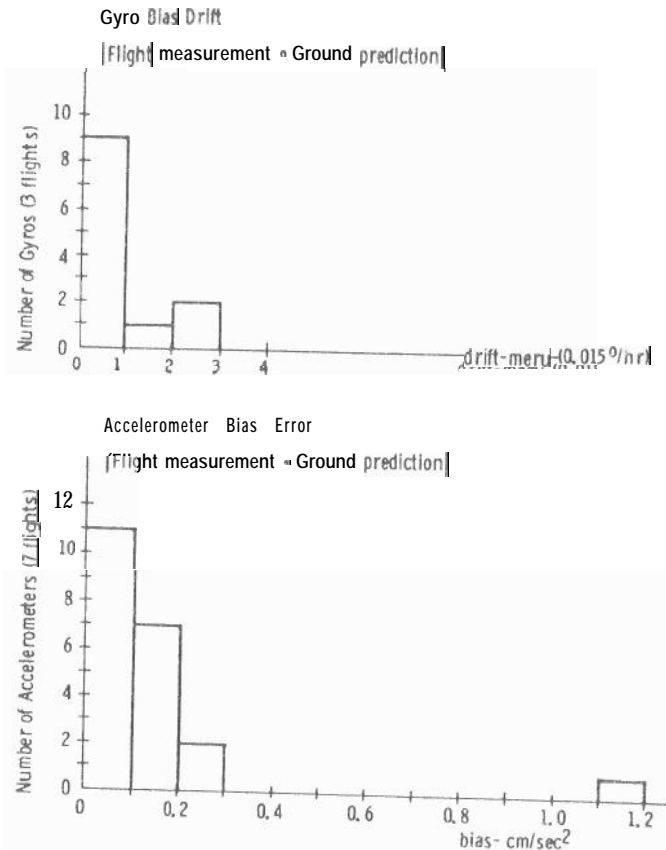
Figure 8 Gyro Bias Drift (NBD) and Accelerometer Bias Flight Data

The inertial component data is presented in Table III and Figure 8.
