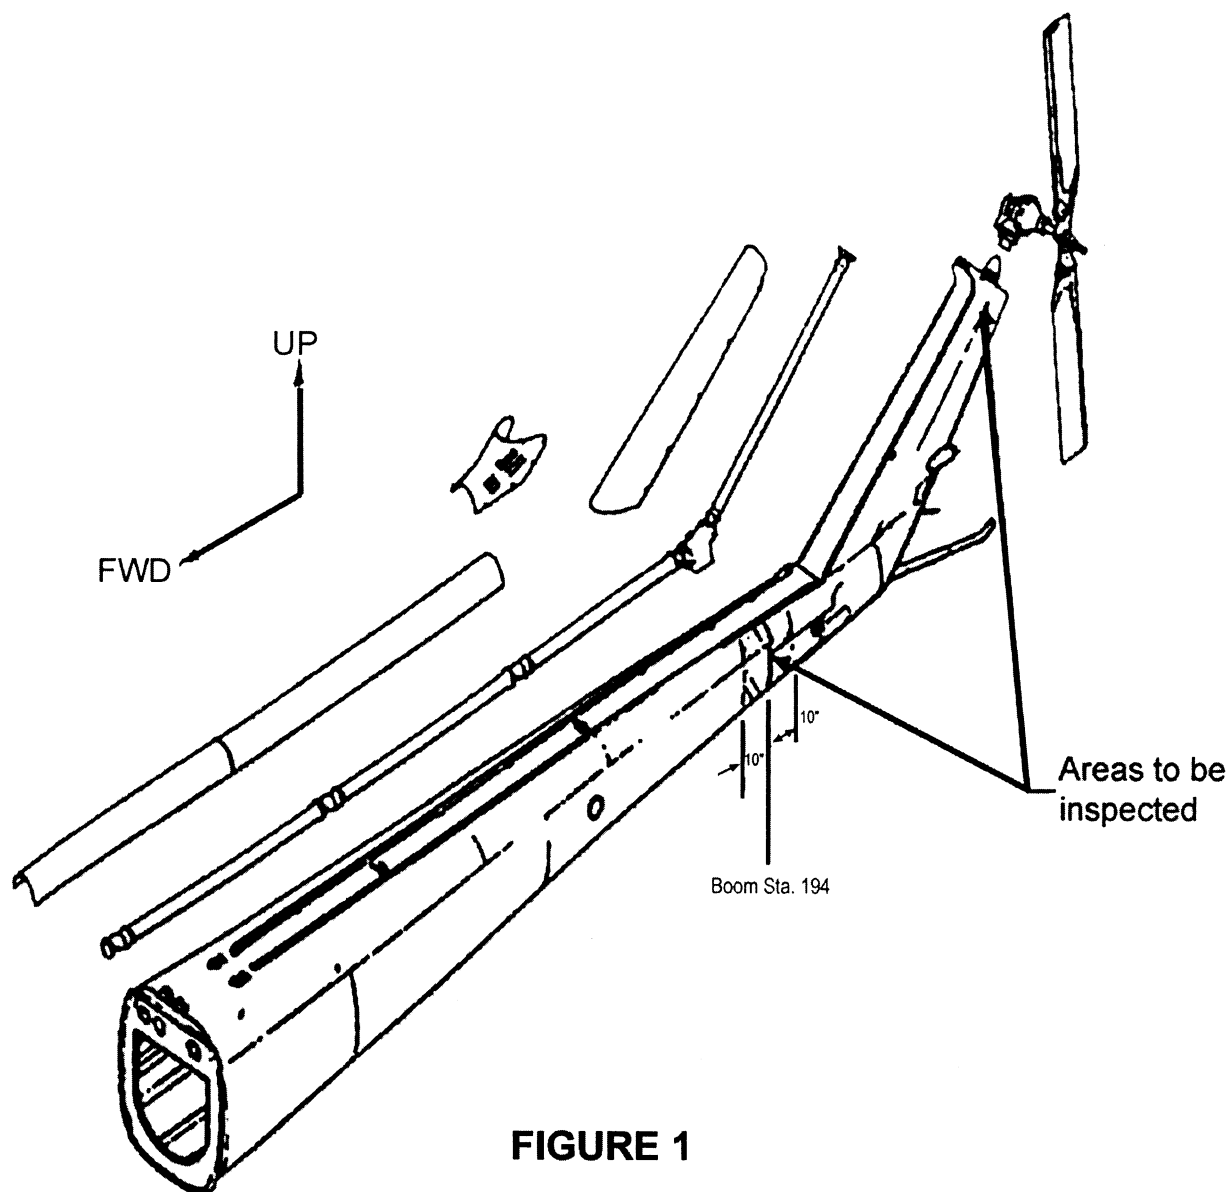
FIGURE 1

Note 2: The tailboom skin joint at BS 194 is located at the bulkhead just forward of the attachment area for the 42-degree tail rotor gearbox assembly (42-degree gearbox) and the intersection between the vertical fin forward canted bulkhead and the lower tailboom skin.

(2) Visually inspect the vertical fin forward spar caps (2) for a crack at the intersection with the tail rotor gearbox support fitting. Refer to Figure 1 of this AD.

(c) If a crack is found in any part, replace it with an airworthy part before further flight. Repair any corrosion or other damage that exceeds the limitations in the maintenance or overhaul manuals before further flight.
