[1.21] TI-89 internal photographs

In case you're curious, the photographs in this tip show a disassembled TI-89, hardware version 1.

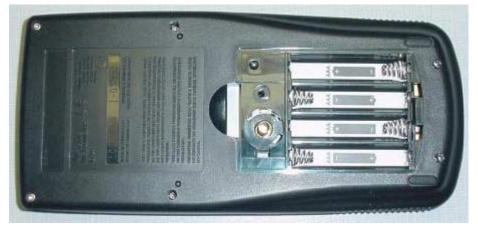
Back cover with batteries and battery covers removed

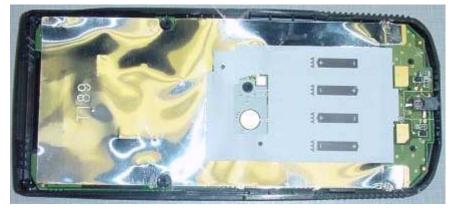
Back cover removed

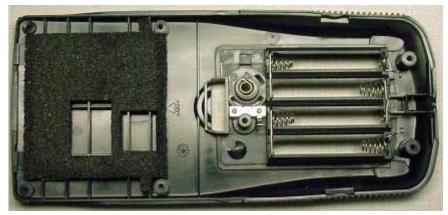
Inside view of back cover

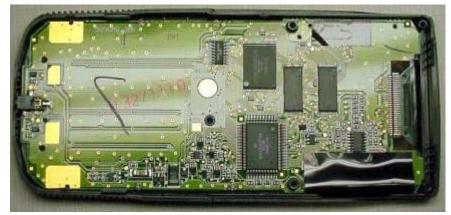
Component side of PCB with shield removed

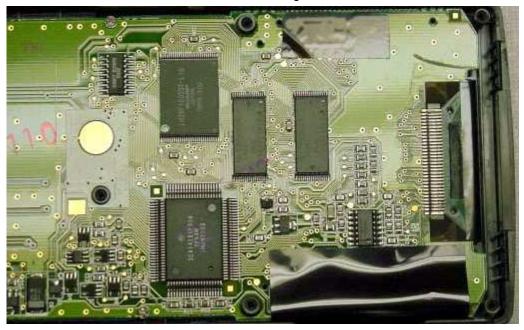
A detail view of the intergrated circuits

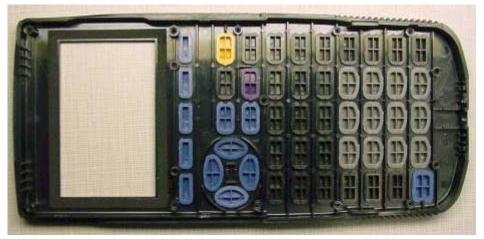
Inside front cover showing keycaps in place
